**Sammie L. Maletta Public Marina
Marina Master Plan**

1.0	MARINA BACKGROUND	1
2.0	EXISTING SITE UTILITIES	2
2.1	Potable Water	2
2.2	Sanitary Sewer	2
2.3	Storm sewer	2
2.4	Electric	2
2.5	Communications	2
2.6	High Tension Wires	3
2.7	Harbor Depths and Navigation	4
2.8	Basin Seawall & Ladders	5
2.9	Retaining Walls	5
2.10	Promenade	6
2.11	Gangways, Gates and Landings	6
2.12	Floating Docks	8
2.12.1	A Dock	10
2.12.2	B Dock	11
2.12.3	C Dock	11
2.12.4	D Dock	11
2.12.5	F Dock	12
2.12.6	G Dock	12
2.12.7	H Dock	13
2.12.8	I Dock	13
2.12.9	J Dock	13
2.12.10	K Dock	14
2.12.11	Transient/Pumpout Dock (T Dock)	15
2.13	Dock Utilities & Pedestals	16
2.14	Dock Fire Protection	18
2.15	Dock Boxes	19
2.16	Launch and Skid Piers	19
2.17	General Site & Landscape	21
2.18	Wayfinding and Connectivity	22

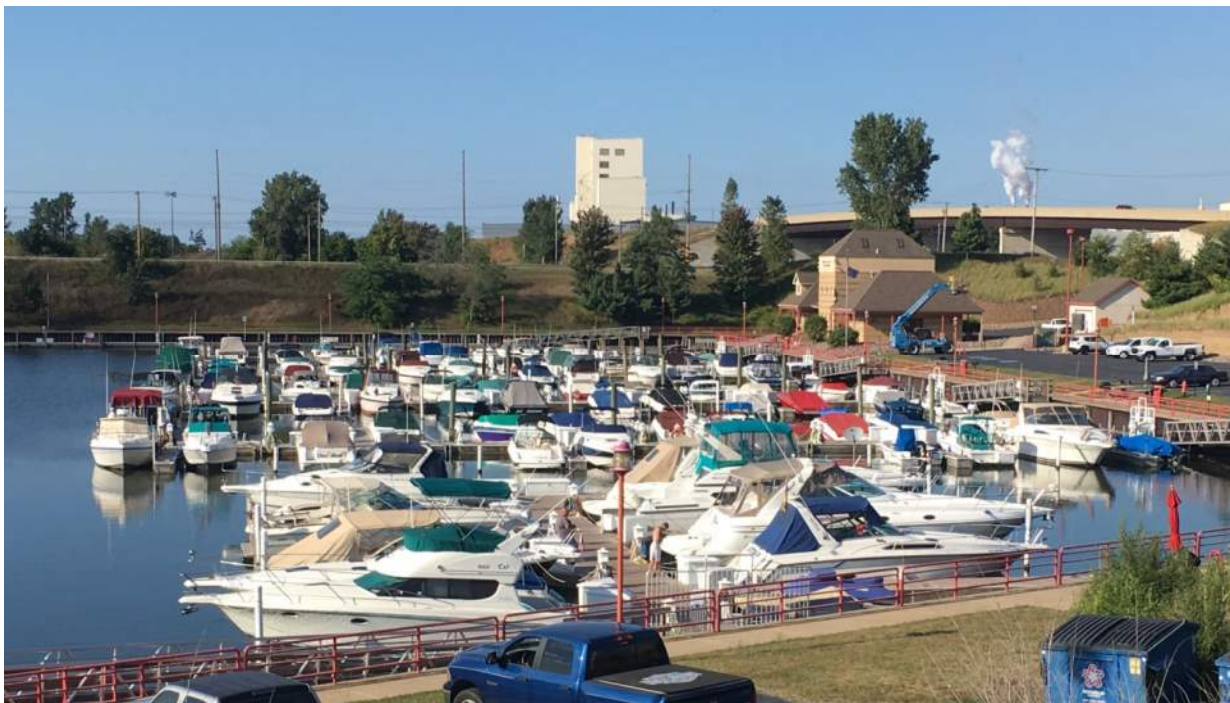
Figure 1: Marina overview, looking north

The marina contains a four-lane boat launch, 214 seasonal slips (including T-head docks) and 400 linear feet of broadside dockage along the north basin wall. The steel sheet pile basin, boat launch, buildings, and site infrastructure were initially constructed in the mid-1990s.

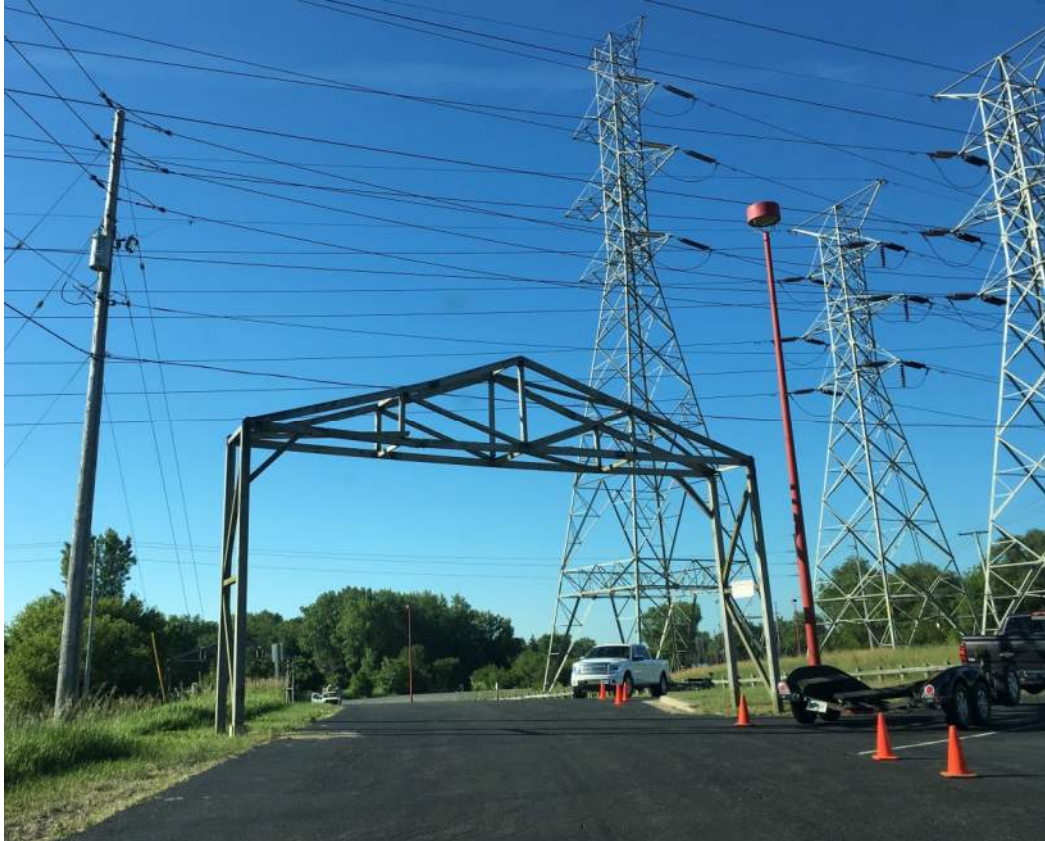
Figure 2: Overhead timber truss

Nipsco high tension wires run through an easement across the property, just south of the marina basin and over some of the entry/parking areas. Overhead timber trusses are located across the site roadways, apparently to ensure vehicle/trailer heights are below a height that could result in arcing (Figure 2). The trusses were likely required when the marina was originally built and any proposed changes to them should be coordinated with Nipsco. The trusses are in poor condition, but were undergoing repairs during the site visit.

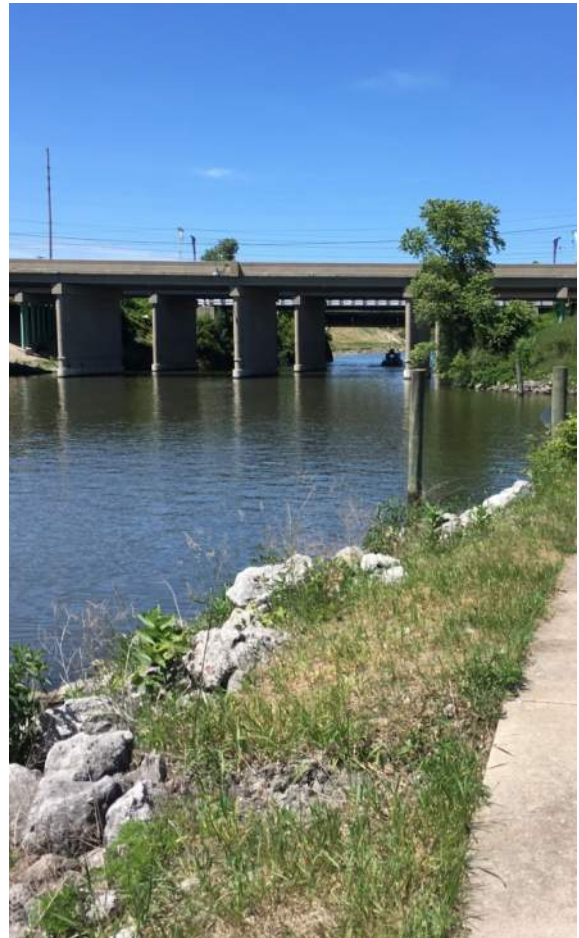
Figure 3: Dunes Highway bridge downstream of marina, looking north

Several bridges are located between the basin and Lake Michigan (Figure 3), including (list order from upstream to downstream):

- Dunes Highway/US-12 (two bridges)
- Amtrak Rail (two rail lines)
- Norfolk Southern Rail (two rail lines)
- Pipe bridge
- Midwest Steel Bridge and rail spur

These bridges restrict vessel heights that can travel to and from Lake Michigan to all of the Burns Waterway marinas, including the Portage Marina.

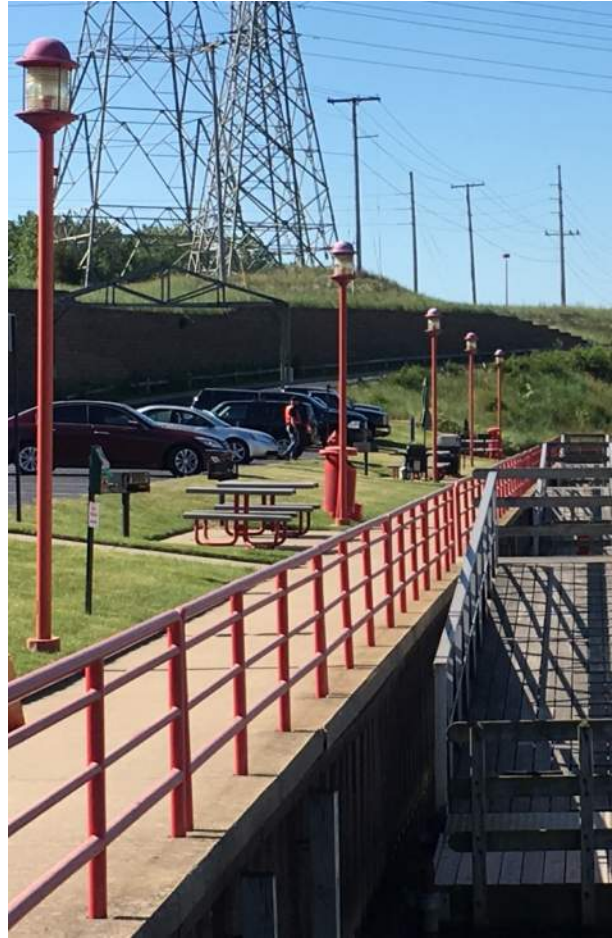
Figure 4: Typical promenade

The promenade that surrounds the marina, parking lots, and buildings is in fair condition, on average. Many of the concrete surfaces are in good condition with few cracks or irregularities. However, some concrete surface joints are exhibiting differential settlement, creating the potential for trip hazards, and possibly signaling underlying issues.

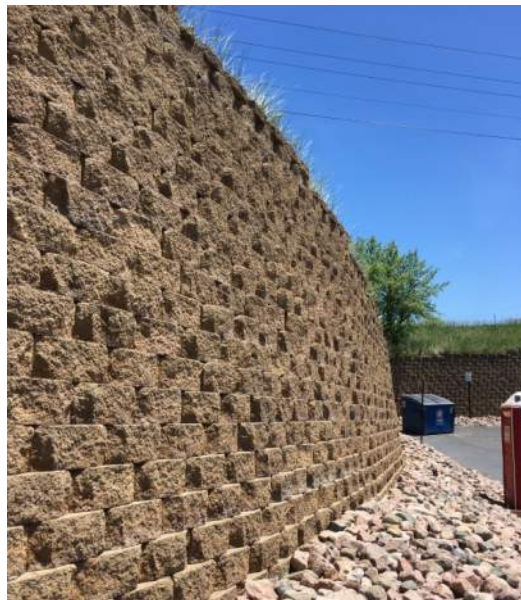
Figure 5: Block retaining wall

The facility contains many block retaining walls to create grade separations and space for parking, roadways, and infrastructure (Figure 5). The walls appeared to be in good condition and no apparent signs of settlement or

drainage issues were observed. Some backfill voids are visible in areas of tight radius transitions by the main building. Block patterns and gaps appear to be consistent throughout the walls observed, indicating that little to no movement has occurred.

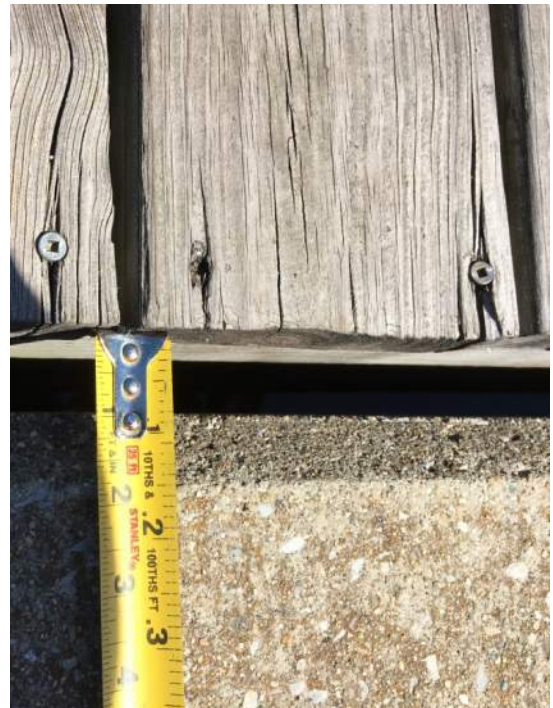
Figure 6: Gangway platform gap

At the top of the gang ways, small, wood-decked platforms extend out from the face of the basin seawall. The platforms are supported by welded steel struts and appear to be in fair condition. However, where the platforms meet the concrete promenade/sidewalk, gaps were observed that exceed 1-1/2 inches (Figure 6). This size of gap is not ADA-compliant and, since decking is also in generally poor condition, the decking should be replaced and the gaps minimized. A steel or aluminum threshold may be needed to span the gaps.

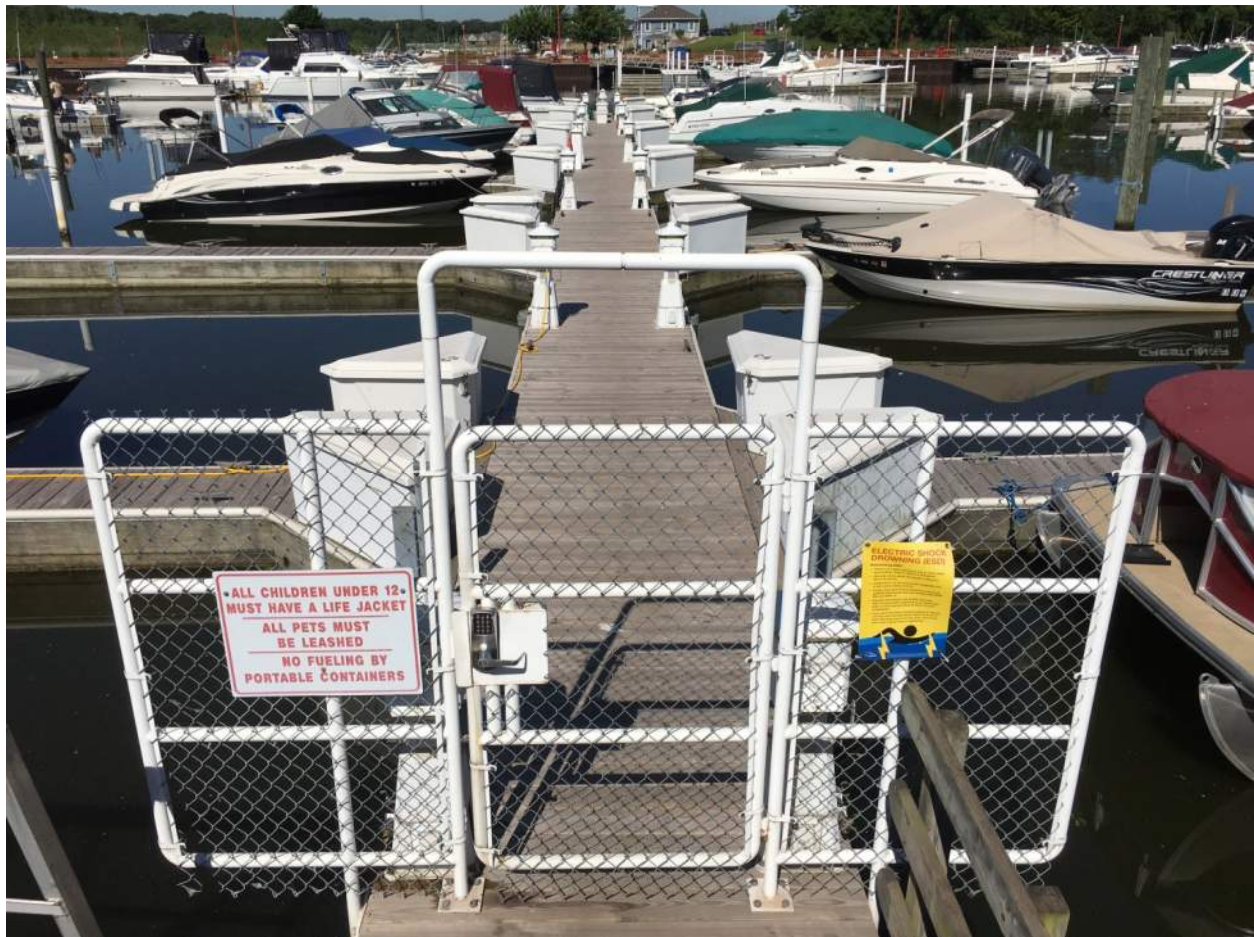
Figure 7: Typical gate & signage

Gate systems are located on the floating docks near the gangway landing areas to provide access control and security (Figure 7). With the exception of F Dock, the gates are a white-painted tube construction, with galvanized chain link panels. The panels extend out over the water to minimize the potential for a trespasser to bypass the gate. The F Dock gate appears to be of newer construction and is constructed of welded, unpainted, aluminum tube. Access to all gates is controlled by key-pad.

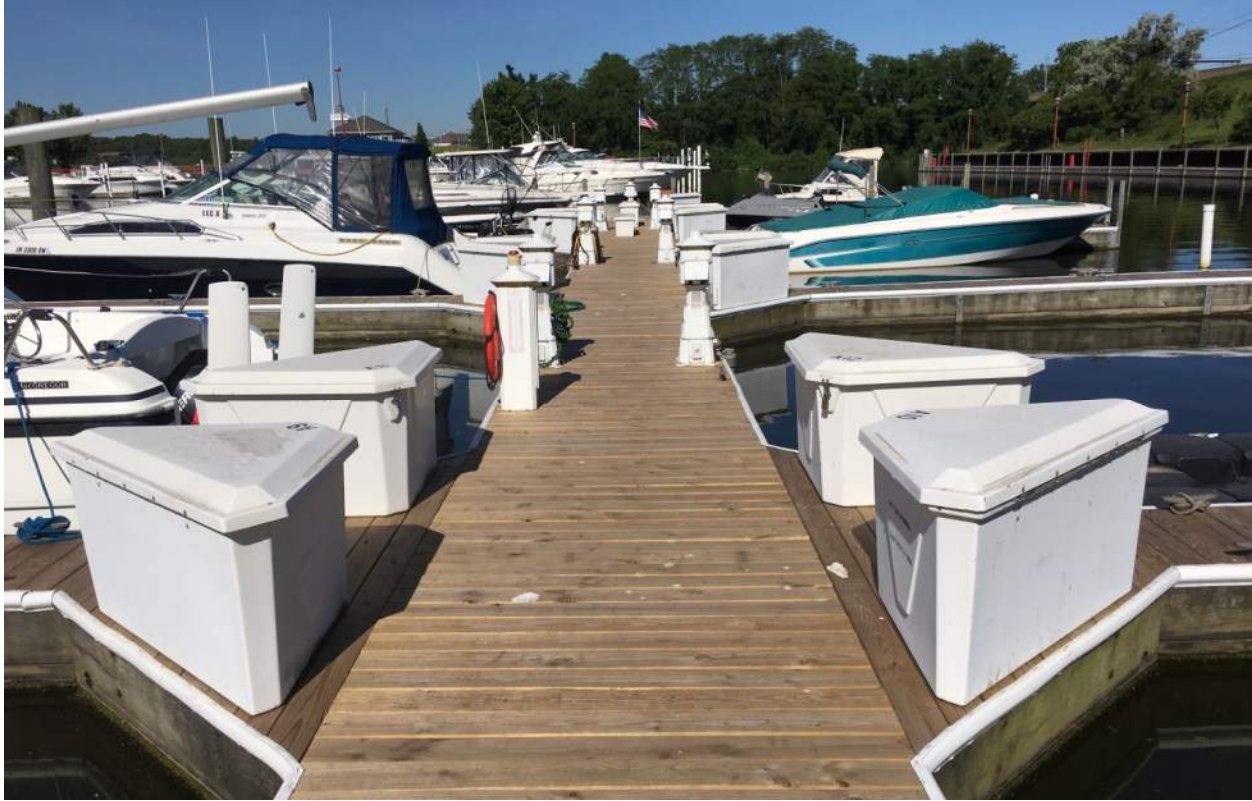
Figure 8: Typical main pier

The floating docks are comprised of a timber and steel hybrid frame, integral polystyrene floatation with sheet steel lamination, and timber decking. All steel components are galvanized to minimize corrosion. The docks were all manufactured by Flotation Docking Systems of Cedarville, Michigan and were originally installed in the mid to late 1990s, although some docks were later added, replaced, or repaired. All floating docks include white, vinyl edging along the edge of the decking to prevent boat hulls from contacting the timber deck edge. The edging is anchored with approximately one-inch-long staples. At broadside dockage areas such as the transient pier and most of the T-head piers (except for F Dock and G Dock), vertical 4"x6" timber fenders were mounted to the floating dock in lieu of the vinyl edging. The vertical timber fenders typically rise four feet above the surface of the decking and have a beveled top. Vinyl edging and vertical timber fenders serve the same function and it is typically a matter of boater preference that leads the decision to install one or the other.

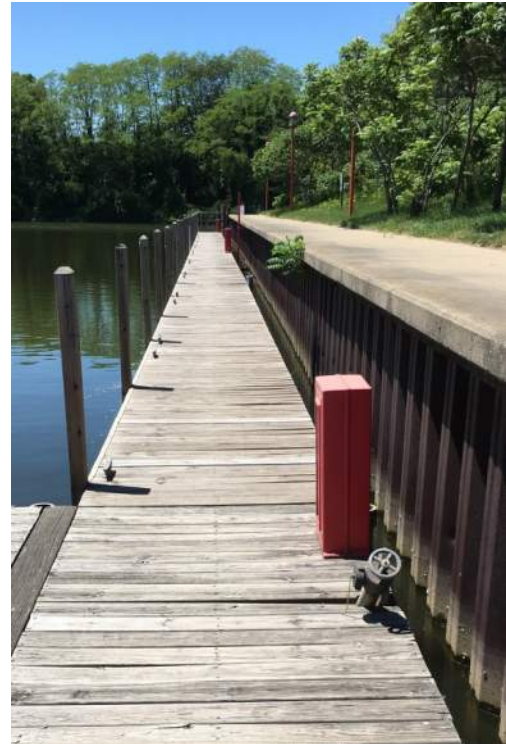
Figure 10: T Dock, looking west

The pump-out area contains two Keco "Pump-A-Head" units. The pump-outs were not tested, however they appear to be as old as the marina. As the T Dock is eventually repaired or replaced, new, more efficient pump-out units should be installed as replacements. Grant funding is likely available for replacement of these units through the Clean Vessel Act (CVA) Pumpout Program.

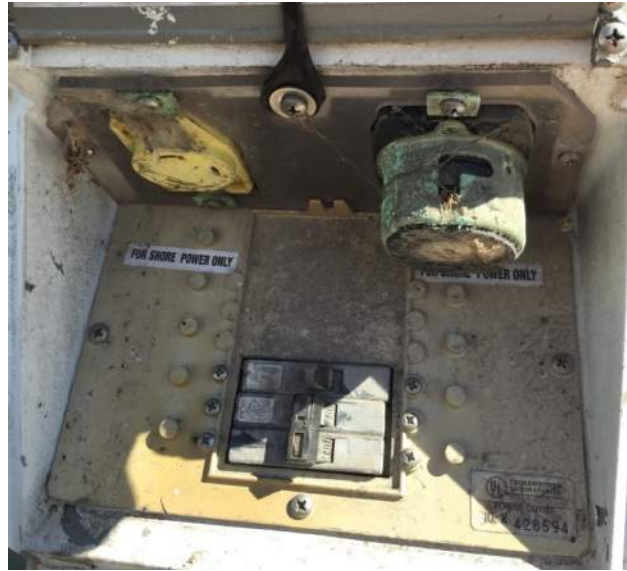
Figure 11: Typical utility pedestal receptacles

The Portage Public Marina provides electricity, water, cable television, and telephone connections to each of its slips through pedestals located on the docks. Typically each pedestal will provide service to the two adjacent boat slips. The cable television and telephone connection signals were not tested for each of the pedestals for this assessment. The models and electrical configuration of the utility pedestals varied from dock to dock. The condition of the pedestals also varied from dock to dock; with docks F, G, H, I, J, and K all being in good condition while docks A, B, C, and D being in fair condition. All of the pedestals are very dirty and could use some cleaning, especially underneath the various covers on the pedestal (Figure 11).

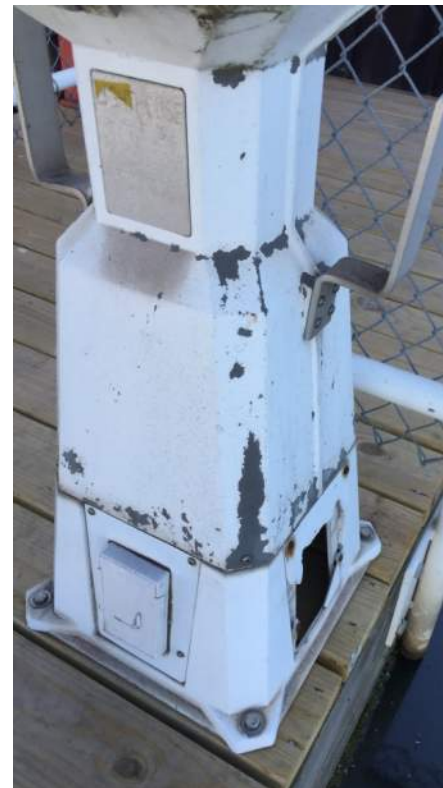
Figure 12: Damaged utility pedestal

There are exceptions where there are different configurations than the typical model. The entire North side of dock A has two 30 Amp connections on each side of the pedestals. On the far end of docks A, B, and C there are 30 and 50 Amp connections on both sides to serve slips 23 and 24. The entire South side and end of dock D has two 30 Amp connections serving each side. Docks A, B, C, and D have a total of 12 broken bottom panels (Figure 12), and only 7 atmospheric vacuum breakers of the total 104 hose connections. Three pedestals were observed leaking water which can lead to premature rotting of the deck

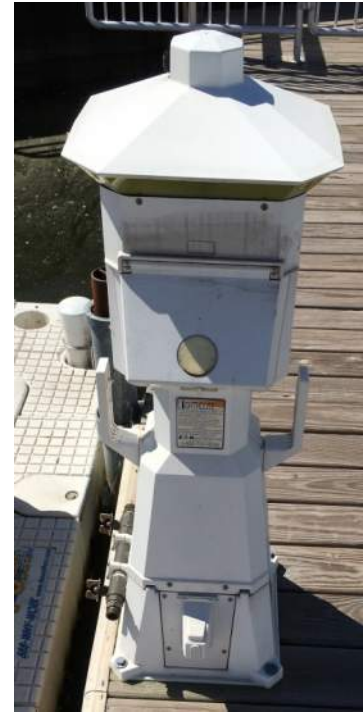
Figure 13: Typical pedestal

Dock G has 3 broken CATV/Telephone connection covers. The pedestals serving slips 13/15, 12/14, and 17/19 on Dock G have two 30 Amp connections on one side and a single 30Amp connection on the other side. No atmospheric vacuum breakers were observed on Docks F or G.

The typical pedestal model found on Docks H, I, J, and K is the Lighthouse Utility Station Model LH3050 manufactured by Marina Power and Lighting. The typical configuration of these pedestals includes the following on each side:

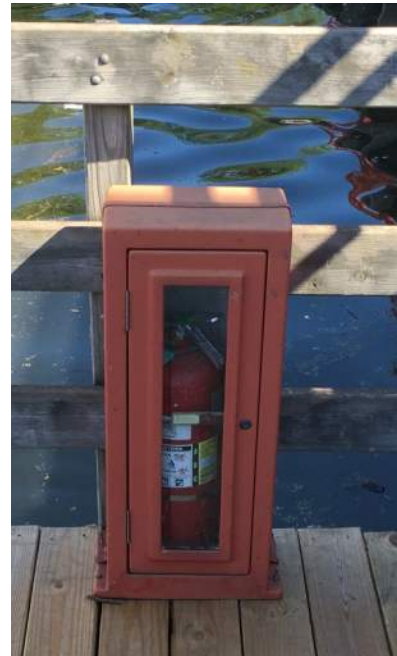
Figure 14: Typical Fire Extinguisher cabinet

In addition, several of the fire extinguishers appeared to have expiration dates in 2017, so replacements are required soon and a review/replacement program must be implemented, if one is not already in place. A recent fire at Hammond Marina is a reminder that accidents do occur and highlights the need to be able to respond quickly to a fire.

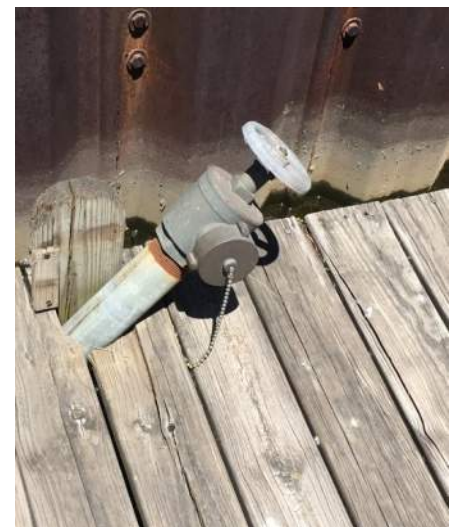
Figure 15: Dry standpipe hydrant

T Dock is the only dock that contains a dry standpipe fire suppression system. A fire hydrant is located near T Dock's connection to land. The connection point to the dry standpipe is located within twenty feet of the hydrant and standpipe hydrants are located along T Dock. The system should be tested to ensure it is in working order. Several of the standpipe hydrants are not aligned vertically, indicating the system may have been damaged in the past (Figure 15).

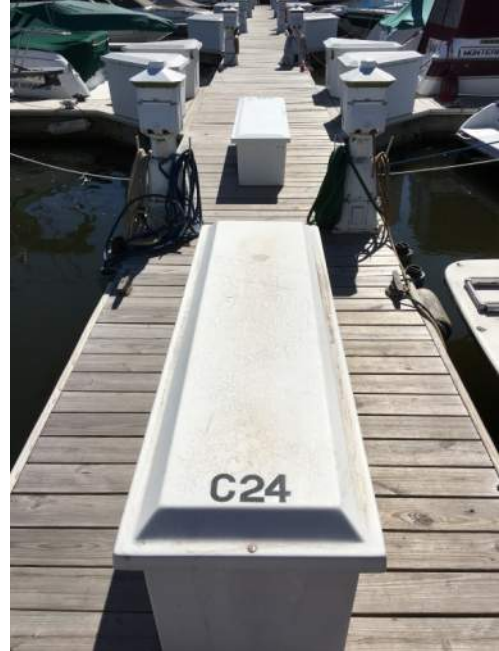
Figure 16: Rectangular dock box

Rectangular dock boxes are located near the end of all of the docks, except F Dock and G Dock (Figure 16). They are anchored to the center of the main pier, leaving minimal clear space to get around the boxes. These dock boxes could lead to accidents and, if not completely necessary, should be removed or replaced with an alternate solution.

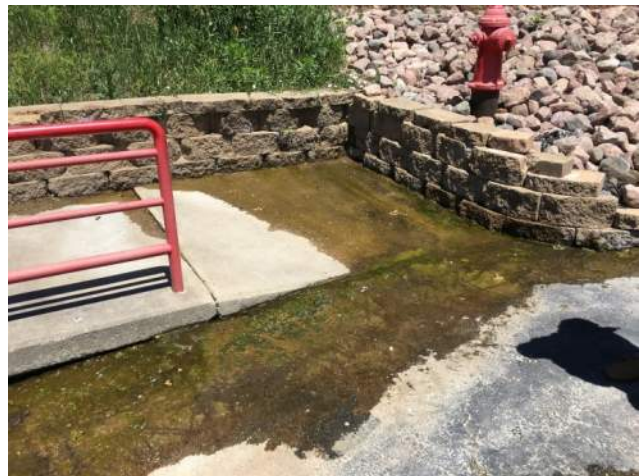
Figure 17: Water issue at T Dock/launch

In general, the concrete launch ramp appears to be in good condition. Minimal cracks are present in the visible sections of these slabs. Water seepage is present on both the north and south edges of the ramp and should be addressed (Figure 17). The seepage on the north side of the ramp is of greater magnitude than the south side a poses some concerns in regards to safety. At this location, algae

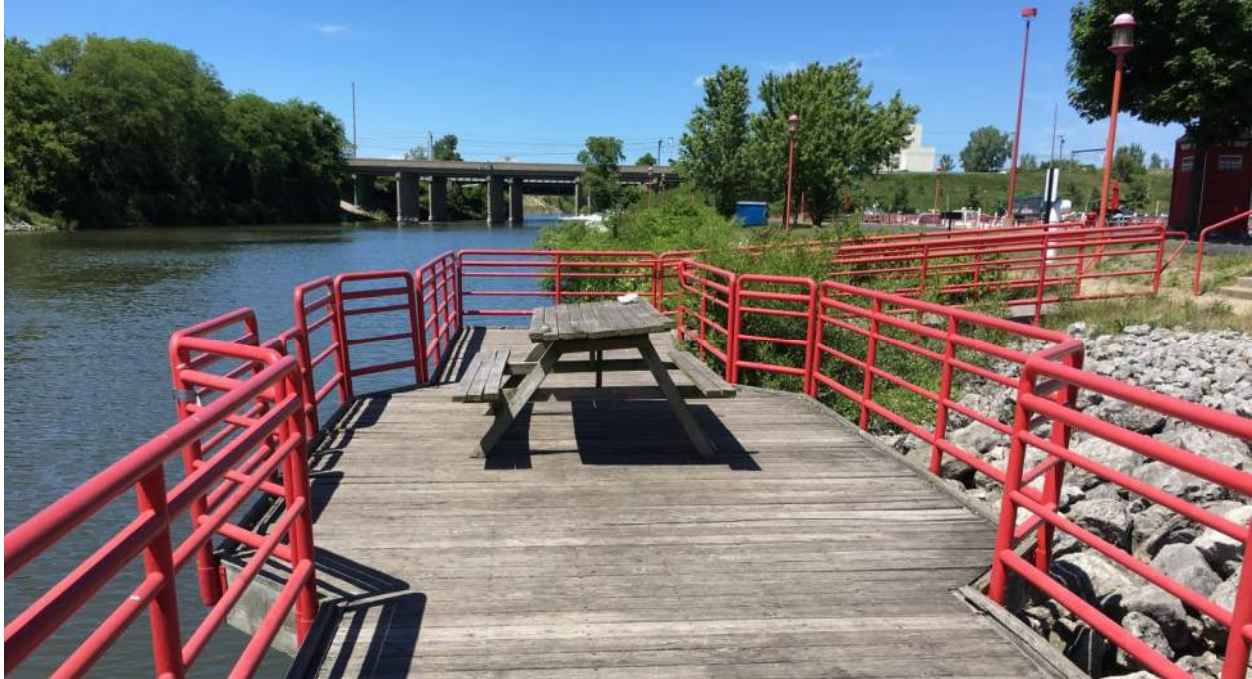
Figure 19: Fishing pier, looking north

Landscaping, amenities, lighting, and other general site features are all beginning to show their age. Underutilized amenities such as the fishing pier are in need of heavy maintenance and repairs. The red site amenities, lights, and railings which are found throughout the facility are faded to more of a pink color. Red-colored site amenities are often the most difficult to maintain, due to fading. As these features are addressed, it is likely the red-colored items will continue to need frequent re-painting. Alternate colors could be considered to minimize long-term maintenance needs.

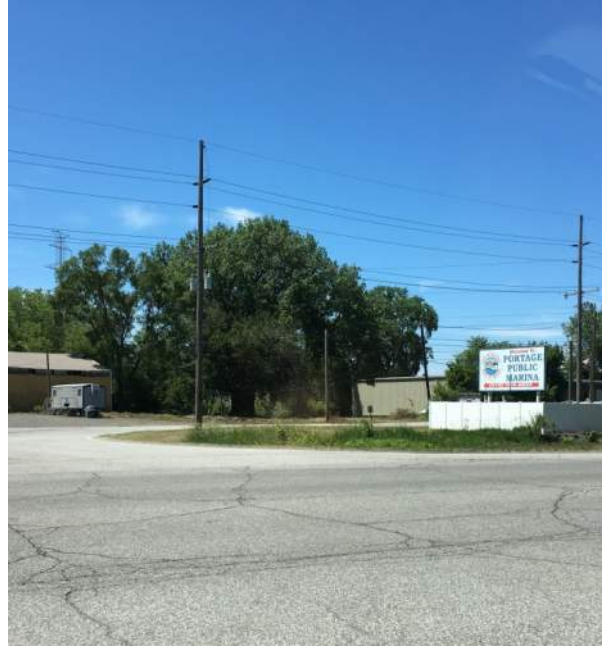
Figure 20: IN-249 sign at right of photo

The large sign signals the location of the marina at the intersection of Marina Court and IN-249, however the sign is easy to miss due to vegetation, traffic, and the width of IN-249 (Figure 20). Additional signage leading to the marina is recommended.

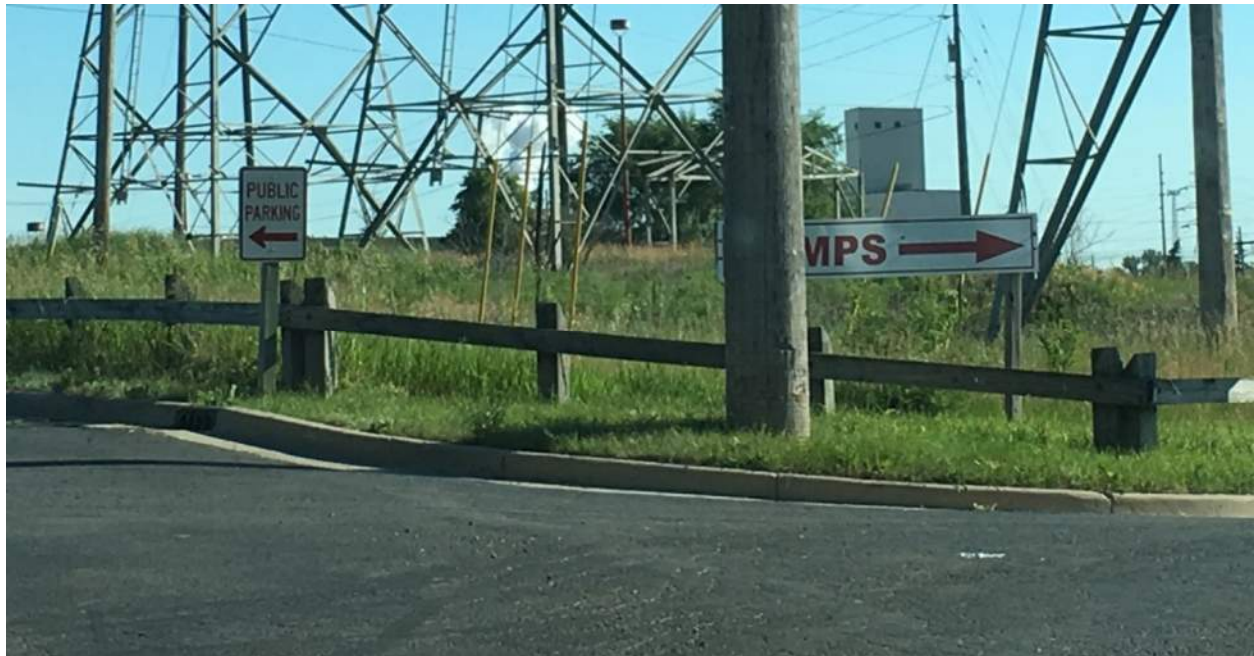
Figure 21: Typical existing wayfinding

Wayfinding and signage within the facility is achieved with smaller, white signs with red lettering, providing clear direction to visitors. However, the signage is plain and the opportunity exists for upgrading the signs along with the overall aesthetics of the facility.

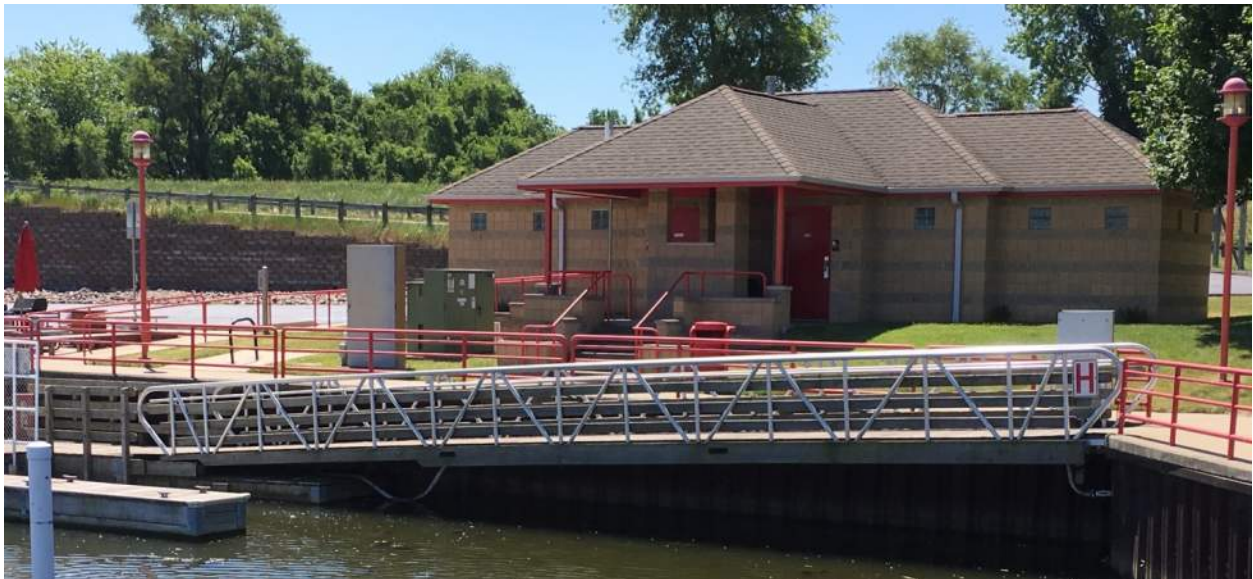
Figure 22: Restroom/shower building, looking south

The overall condition of the building is very good. Signs of age are obvious but there are no significant problems/repairs required. Minor repairs are needed as well as some work that is a result of a different heating and cooling system having been installed – since the original construction date.

Major expenses anticipated due to the age of the building include: roof and water heater replacement within the next 1-5 years, replacement of the HVAC equipment, plumbing fixture flush valves, faucets and countertops is anticipated.

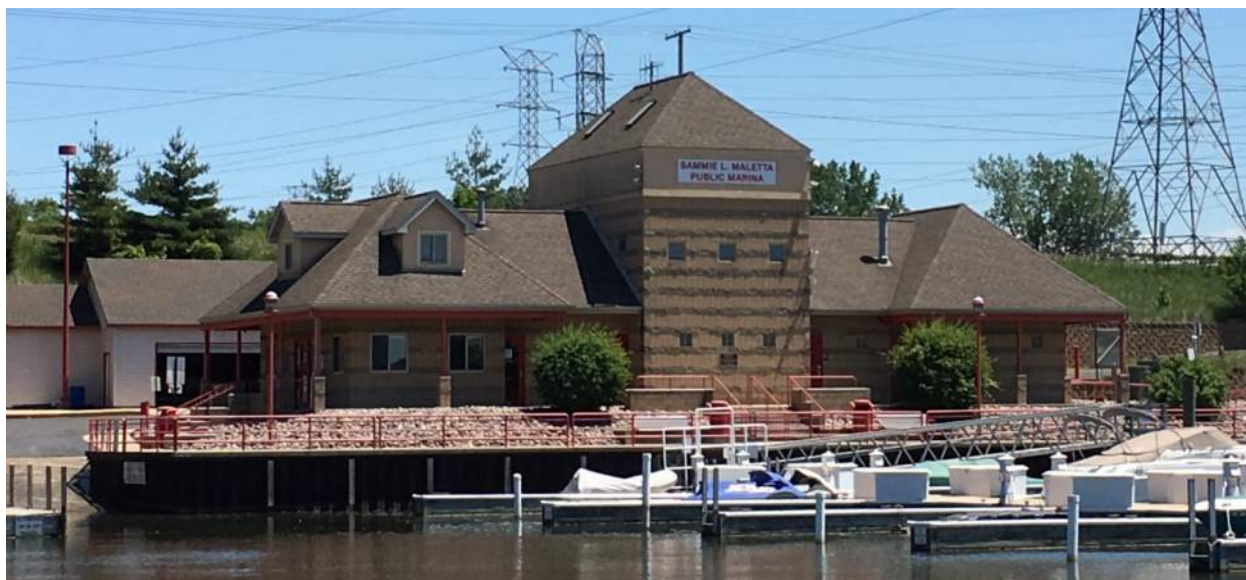
Figure 23: Marina office/support building

At the interior, most flooring at offices requires replacement as well as suspended ceiling pads. Since the building was not designed originally for year-round occupancy, some improvements are needed to enhance staff comfort levels and energy efficiency. Exterior doors should be replaced at the office with insulated glass units. Exterior walls at utility room/water service should be insulated. At attic area (in tower), a ceiling should be installed and insulation installed above – roof area currently is not insulated. The exterior wall at the stairway in this room also should be insulated.

Major expenses anticipated in the next ten years include: roof, furnace, and A/C unit replacement. Also, plumbing flush valves and faucets will need replacement.

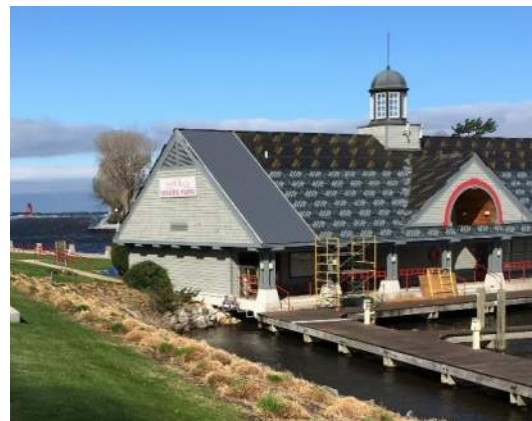
Figure 27: New steel roof installation example; City of South Haven, South Side Marina

In addition, new roofs will be needed soon for each of the buildings and steel roofs are being considered, both for efficient life-cost and for aesthetic improvement opportunities. Steel roofs would be intended to match the color scheme selected, utilizing a fade-resistant color.

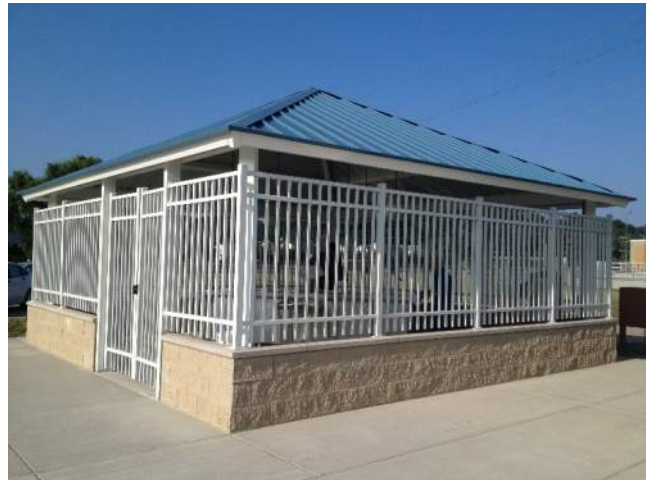
Figure 28: Modern, secure fish cleaning station example

Survey feedback, public comments, high launch usage, and staff observations all indicate that fishing is a popular activity for boaters utilizing the marina. Yet, currently no fish cleaning station is provided. Fish are still cleaned on site, at personal/folding cleaning tables, or, in some cases, at picnic tables. Fish remains are discarded near the shore or in trash receptacles, creating a nuisance odor. A new fish cleaning station would serve as an additional draw to the facility, would support the boaters and public, and allow the proper disposal of fish remains. A grinder capable of handling the types of fish commonly caught on Lake Michigan would be incorporated.

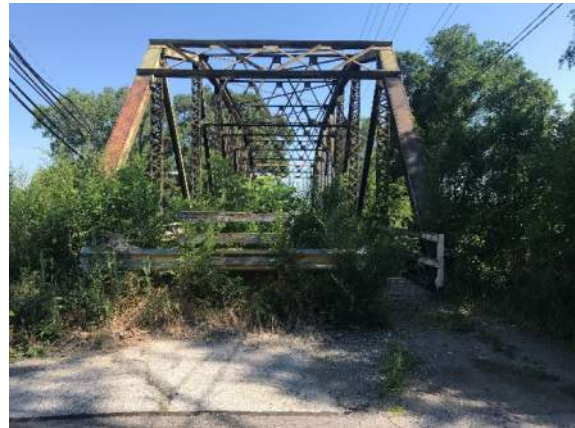
Figure 31: Chrisman Bridge, looking north

the Portage Lakefront Park. In addition, the trail plan includes an extension of the trail south from the marina, along Crisman Road, and across Burns Waterway via a proposed rehabilitated Crisman Road bridge (Figure 31). This southern connection would be the final segment between the Portage regional trail system and the lakefront.

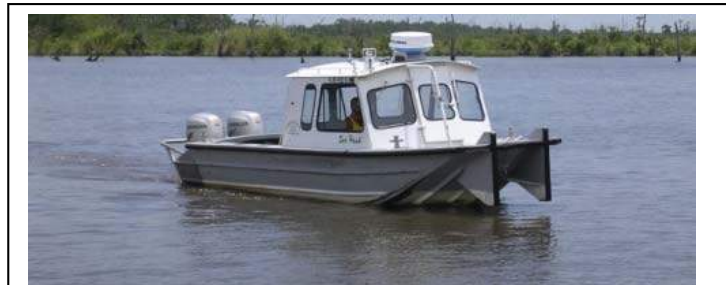
Figure 2.1 – Mary Rose

Passenger capacity: 6

Trailer: Galvanized, twin axle

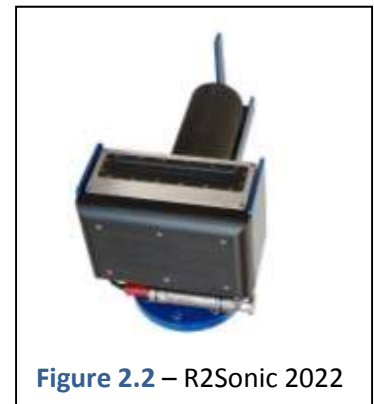
Figure 2.2 – R2Sonic 2022

The R2Sonic 2022 multibeam sonar system scans underwater features using a high-resolution swath of 256 beams with beam widths of 1° across-track and 1° along-track (1° x 1° system). The system can be operated in either equidistant or equal-angle operating modes, with a swath coverage angle of up to 160°. The sonar operates at user-selectable frequencies between 200kHz and 400kHz.

A continuous sound velocity profile is normally measured by velocity probe casts and then corrected for within the processing software. Additionally, real-time sound velocity is monitored at the sonar head using a head-mounted SV probe.

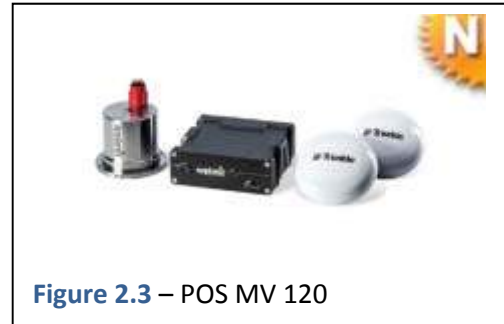
Figure 2.3 – POS MV 120

Horizontal and vertical positioning were accomplished using an Applanix POS MV 120 Position & Orientation system. The POS MV 120 package uses RTK (Real Time Kinematic) GPS technology which is capable of receiving both L1 & L2 frequencies as well as the GLONASS satellites. Equipment is capable of achieving positioning accuracies of up to $\pm 0.10'$, both horizontally and vertically. The RTK positioning equipment is capable of rapid update rates $>5\text{Hz}$, allowing it to be used for real-time heave compensation.

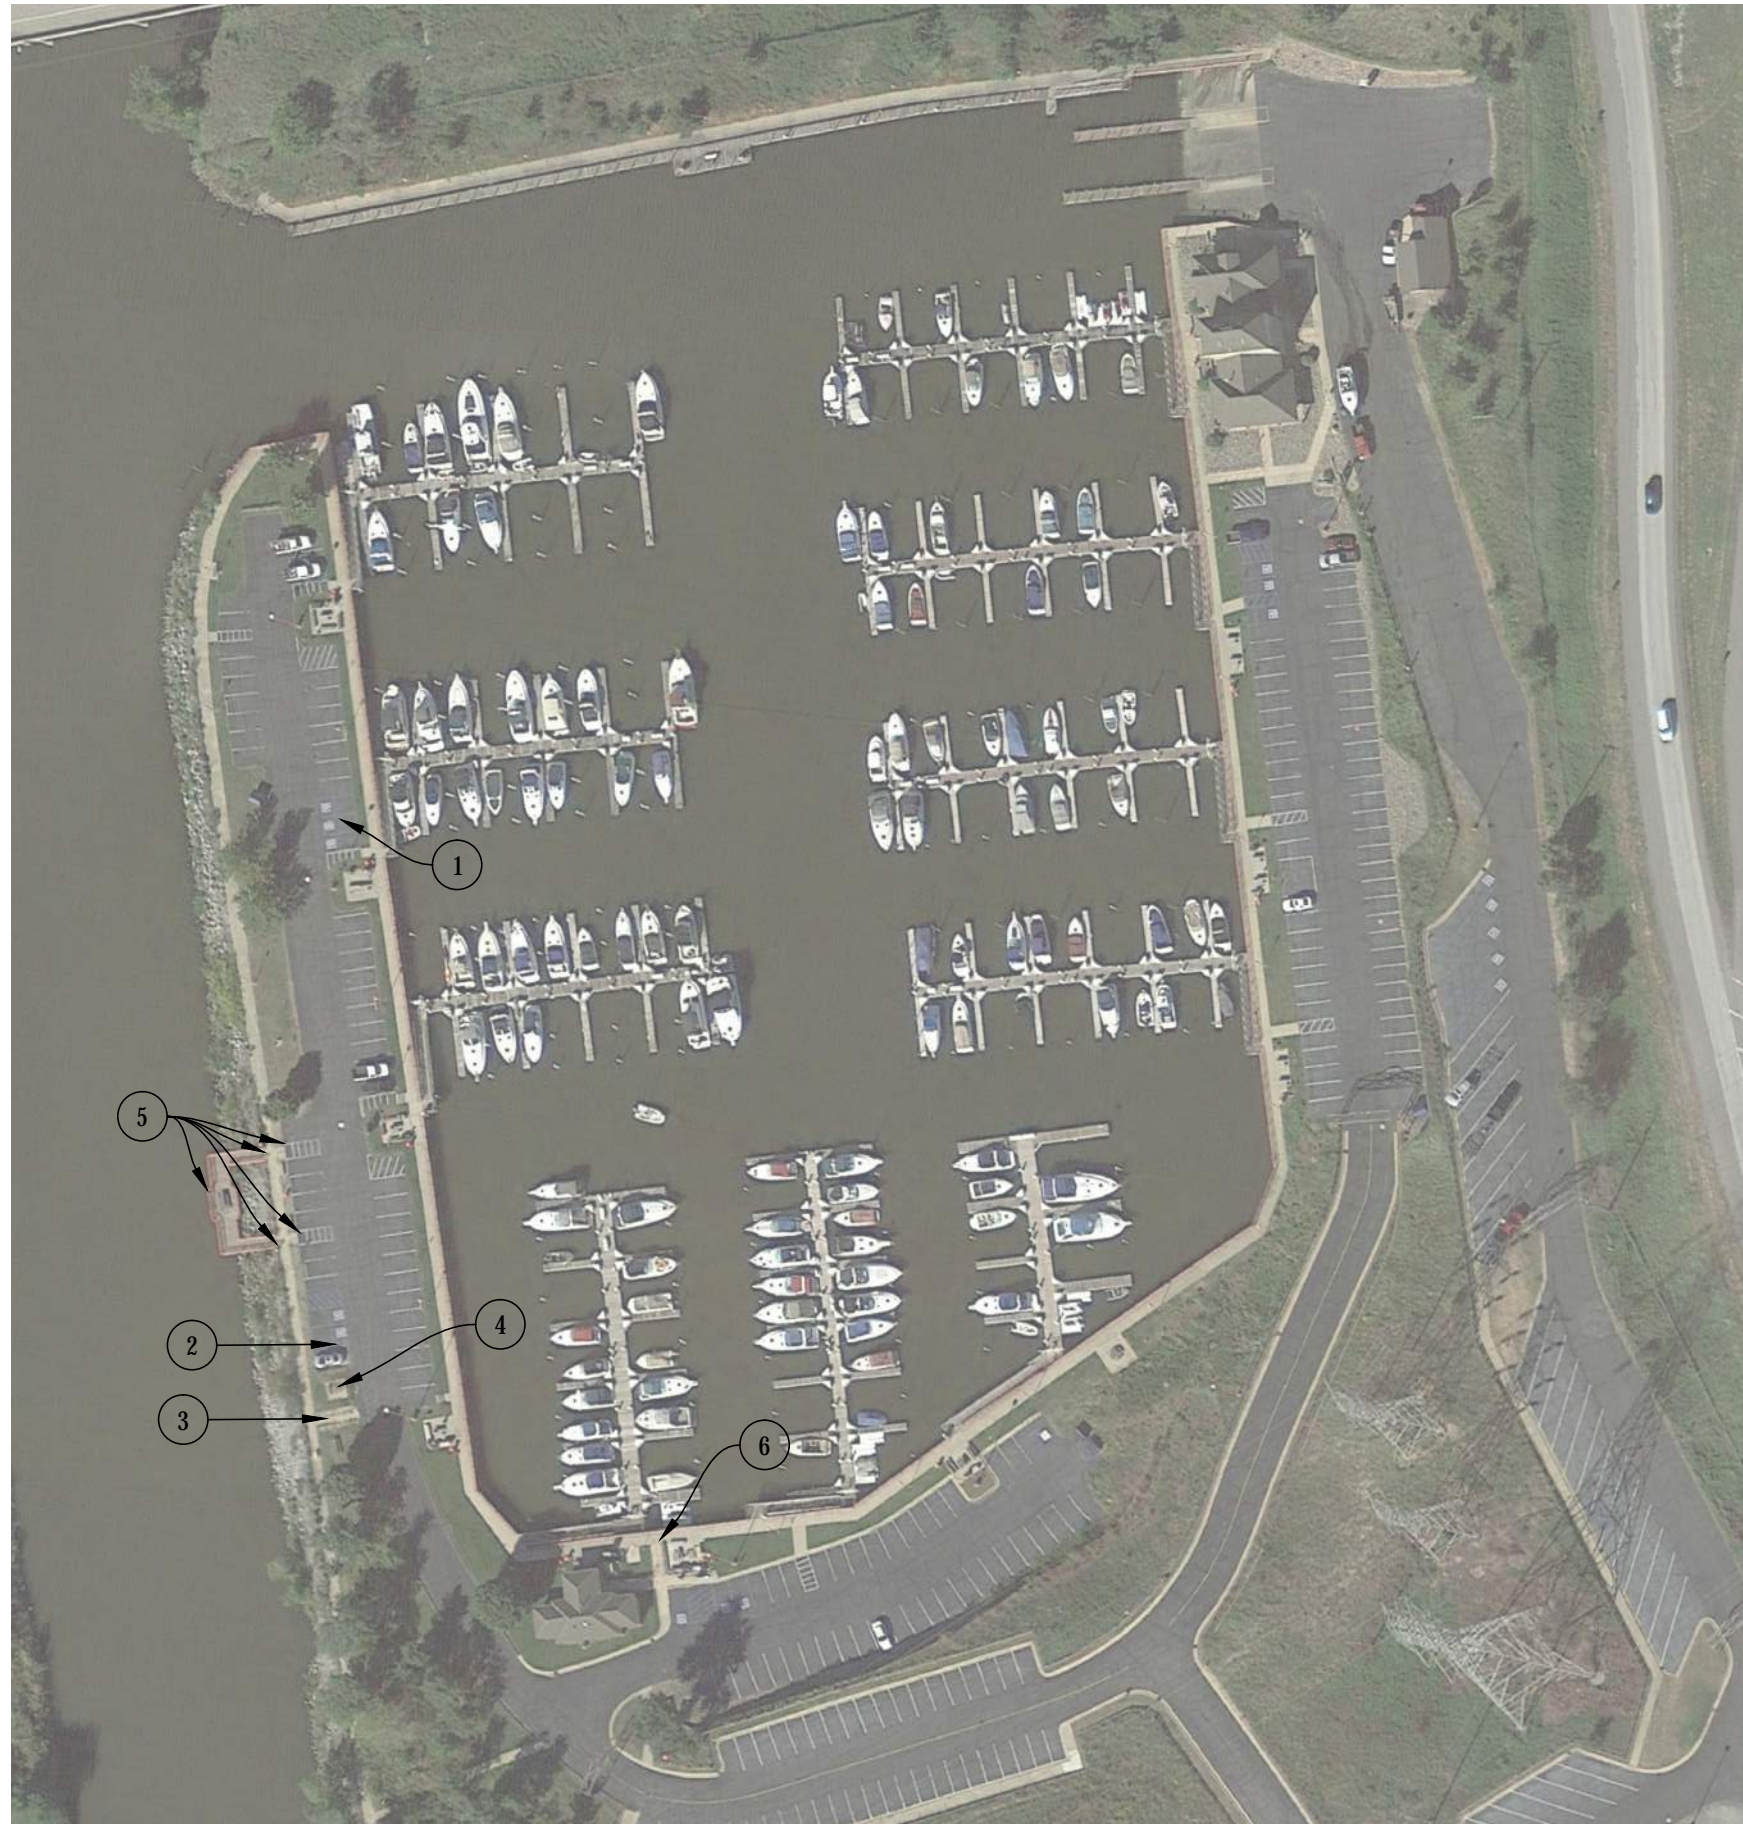
1. ADA PARKING SPACES - ORIGINAL 2 ADA PARKING SPACES WITH 2 SIGNS CONVERTED TO 3 ADA PARKING SPACES WHICH ELIMINATED ACCESSIBLE AISLE. REMOVE MIDDLE SPACE AND STRIPE AS ACCESSIBLE AISLE.

5. FISHING PLATFORM RAILINGS DO NOT MEET CURRENT ACCESSIBILITY REQUIREMENTS FOR PERCENTAGE OF ACCESSIBLE RAIL. RAILINGS FOR RAMP AND STAIRS PROTRUDE INTO THE ACCESSIBLE ROUTE. IF FUTURE IMPROVEMENTS ARE MADE TO THE PLATFORM RECOMMEND REPLACEMENT OF RAILINGS TO MEET CURRENT REQUIREMENTS. CONSIDER ALTERNATE ACCESSIBLE ROUTE TO ELIMINATE RAILING PROTRUSION.

6. BOATER RESTROOM/SHOWER - RAILINGS FOR LOWER RAMP DO NOT MEET CURRENT STANDARDS - TO EXTEND 12" BEYOND LEVEL LANDING. RAILING ON RAMP PARALLEL TO FACE OF BUILDING NOT NEEDED AS SLOPE IS BELOW 5%. RAMP PERPENDICULAR TO MARINA IS AT 5.3% SLOPE REQUIRING A HANDRAIL. IF EXTENDED HANDRAILS WOULD PROTRUDE INTO MARINA WALKWAY AND LEVEL LANDING AT TOP OF RAMP. EXTENSION OF HANDRAIL WOULD CREATE A HAZARD DUE TO PLAN CONFIGURATION OF WALKWAYS..
