**Sammie L. Maletta Public Marina
Marina Master Plan**

1.0	MARINA BACKGROUND	1
2.0	EXISTING SITE UTILITIES	2
2.1	Potable Water	2
2.2	Sanitary Sewer	2
2.3	Storm sewer	2
2.4	Electric	2
2.5	Communications	2
2.6	High Tension Wires	3
2.7	Harbor Depths and Navigation	4
2.8	Basin Seawall & Ladders	5
2.9	Retaining Walls	5
2.10	Promenade	6
2.11	Gangways, Gates and Landings	6
2.12	Floating Docks	8
2.12.1	A Dock	10
2.12.2	B Dock	11
2.12.3	C Dock	11
2.12.4	D Dock	11
2.12.5	F Dock	12
2.12.6	G Dock	12
2.12.7	H Dock	13
2.12.8	I Dock	13
2.12.9	J Dock	13
2.12.10	K Dock	14
2.12.11	Transient/Pumpout Dock (T Dock)	15
2.13	Dock Utilities & Pedestals	16
2.14	Dock Fire Protection	18
2.15	Dock Boxes	19
2.16	Launch and Skid Piers	19
2.17	General Site & Landscape	21
2.18	Wayfinding and Connectivity	22

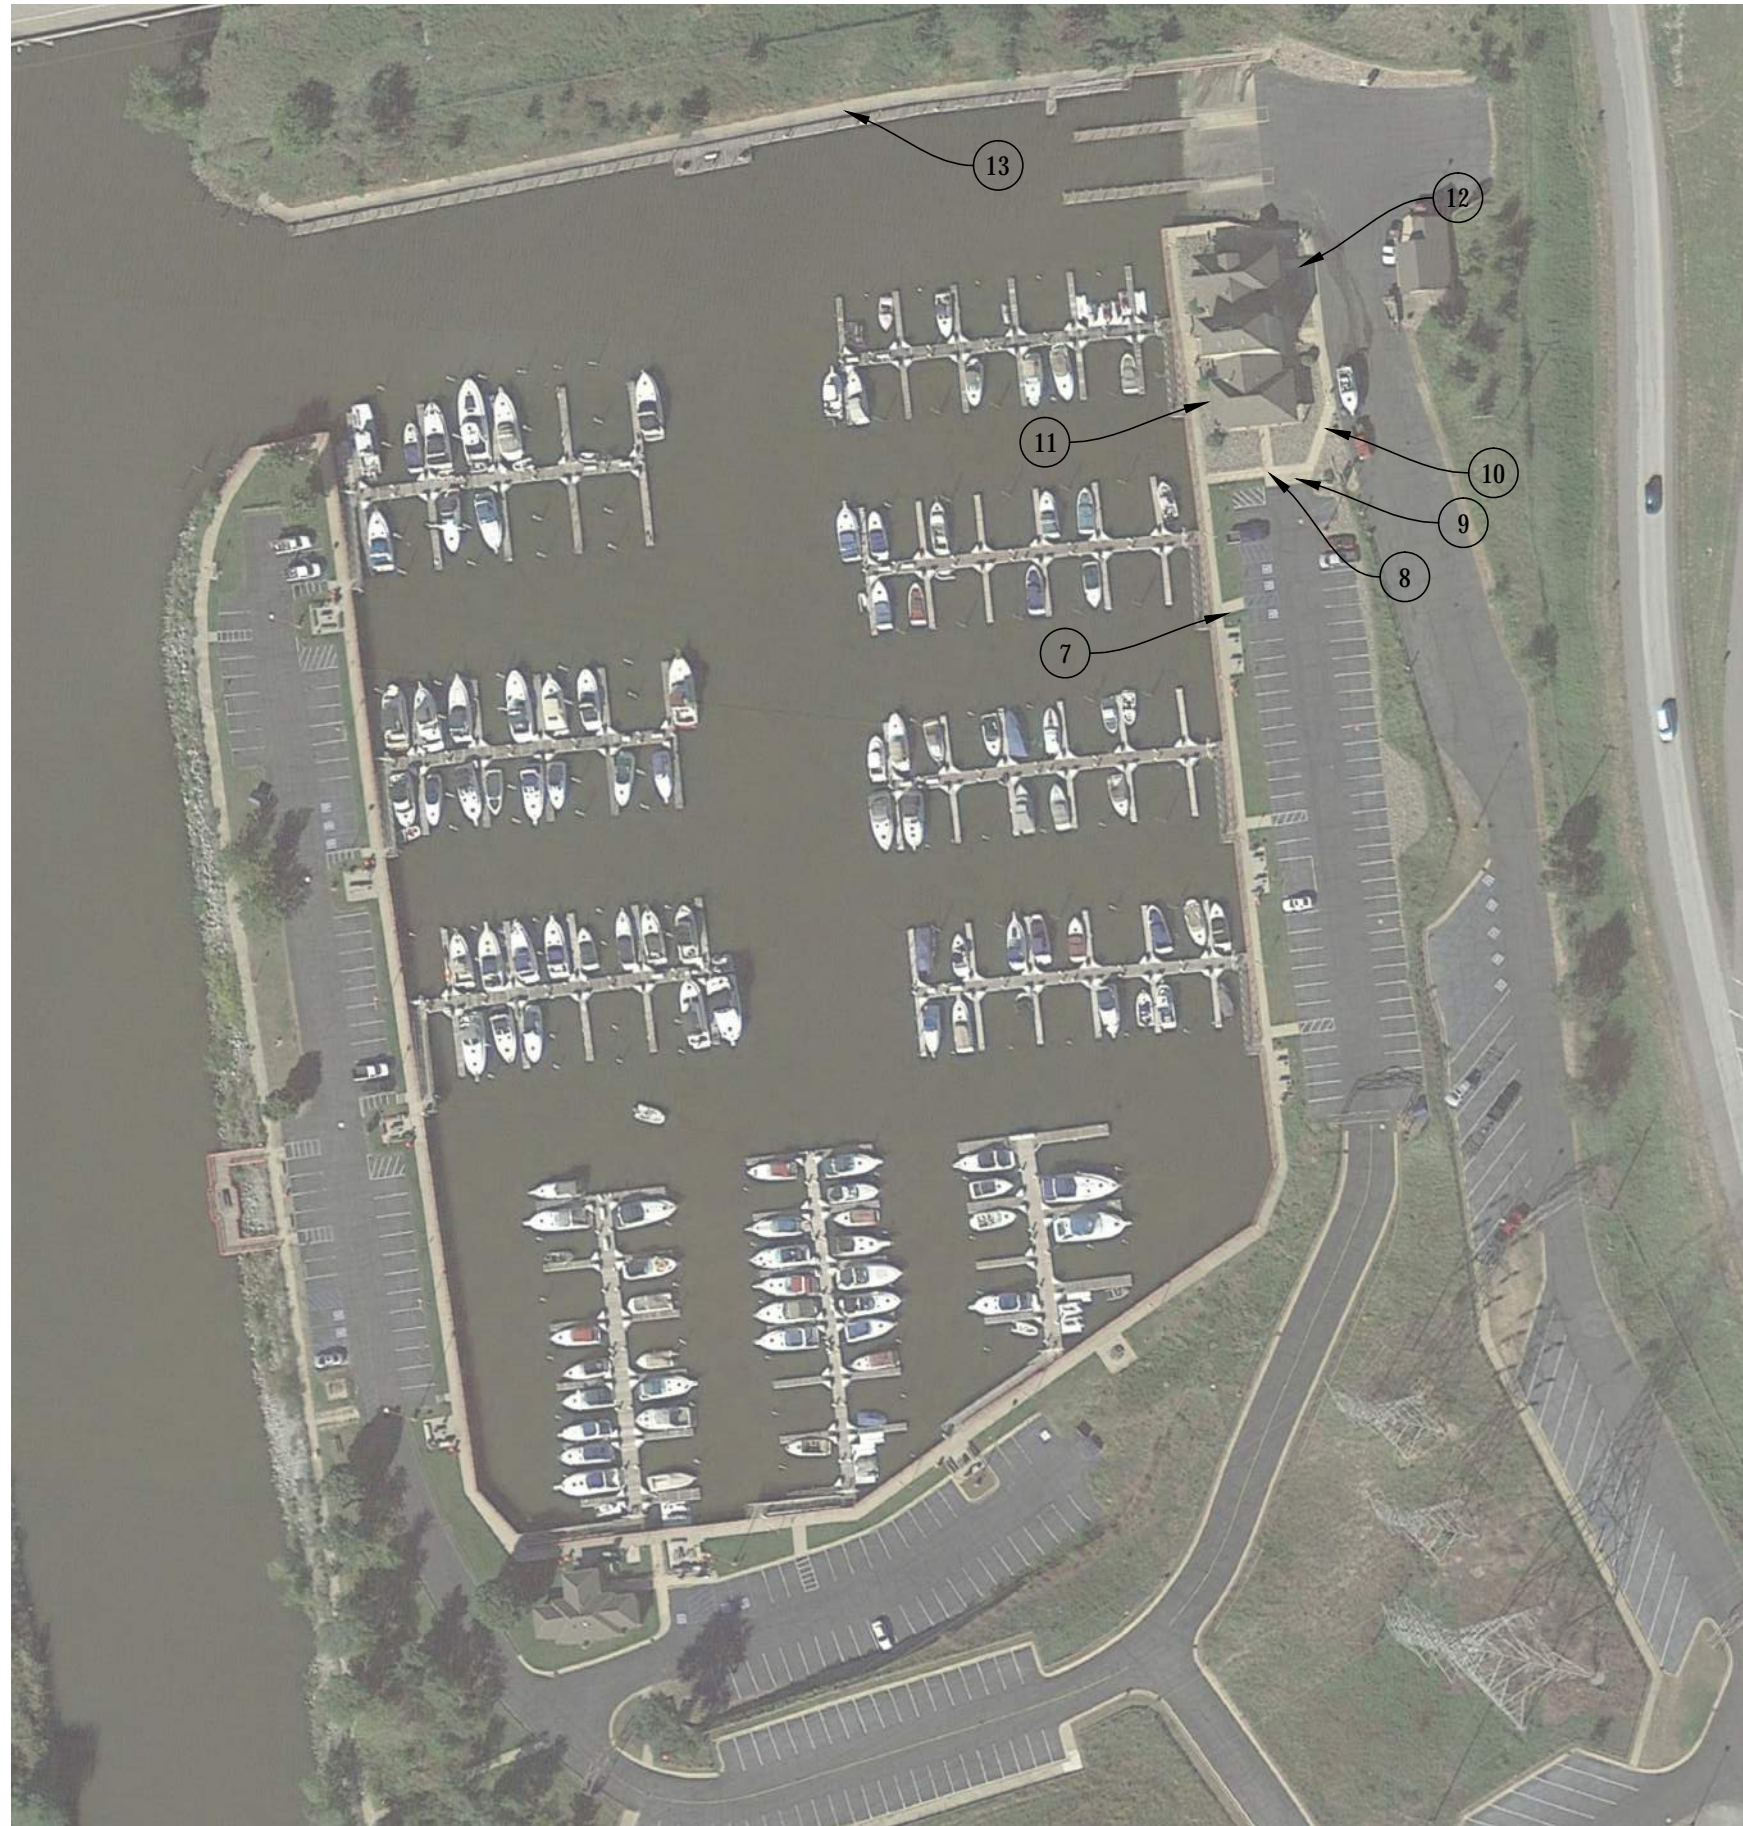
7. ADA PARKING SPACE SIDEWALK ADDED TO CONNECT TO MARINA WALKWAY IS SLOPING AT 7.5% AND IS HEAVED AT THE BASE CREATING A TRIP HAZARD. WALKWAYS SLOPING AT OVER 5% BECOME A RAMP REQUIRING HAND RAILINGS. WOULD RECOMMEND EITHER REDUCING SLOPE TO LESS THAN 5% WITH A WALK WITH SWITCH BACK OR IF POSSIBLE MAXIMIZING RAMP GRADE TO 8.33% AND ALLOWING 12" LEVEL AREA AT BASE OF WALK SO HANDRAIL DOES NOT PROTRUDE INTO MARINA WALKWAY AT LANDING.

8. ADA RAMP AT EAST END OF BOATHOUSE DOES NOT HAVE A LEVEL LANDING - RECOMMEND WHEN MILL AND FILL OF ADJACENT ASPHALT PAVEMENT, RE-POUR LANDING TO HAVE LESS THAN 2% OF SLOPE IN ALL DIRECTIONS.

9. EXISTING BIKE RACK IS IN A LOCATION WHERE SECURED BIKE WOULD PROJECT INTO WALKWAY OR STICK OUT INTO ASPHALT PARKING AREA. RECOMMEND RELOCATING BIKE RACK TO LEVEL AREA WITH ADEQUATE SPACE TO ACCOMMODATE 2' WIDE X 6' LONG BIKE WITHOUT PROJECTING INTO CIRCULATION ROUTES.

10. ANGLED SIDEWALK HAS A SEVERE CROSS SLOPE OF ALMOST 4 %. CROSS SLOPES SHOULD BE 2% MAX. WOULD RECOMMEND REMOVAL OF WALK AND CONCRETE AREA ADJACENT TO PARKING LOT TO CREATE A LEVEL LANDING AND INSTALL WALKWAY TO MEET CURRENT STANDARDS.

11. EDGE OF WALKWAY SHOULD HAVE A EDGE PROTECTION EITHER A CURB OR ADD STONE TO EXTEND ABOVE THE GRADE OF THE WALK TO CREATE A LIP.
12. WALKWAY LEADING TO HARBOR MASTER AREA DOES NOT HAVE A LEVEL LANDING TO TRANSITION ONTO WALK. RECOMMEND EITHER CREATING LEVEL LANDING OR ADD SIGNAGE DIRECTING USER TO ACCESSIBLE RAMP TO SOUTH.

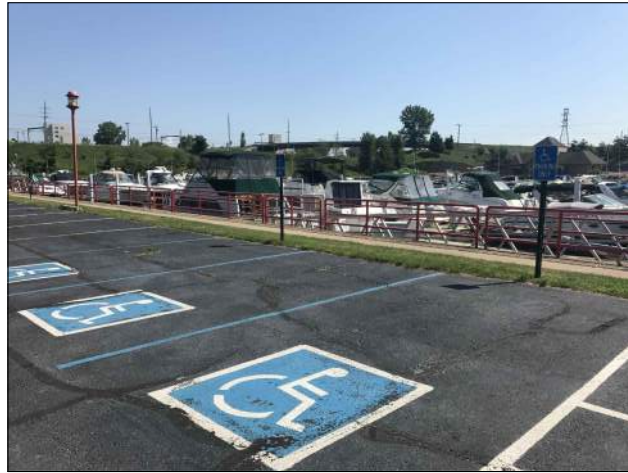
1. ADA PARKING SPACES - ORIGINAL 2 ADA PARKING SPACES WITH 2 SIGNS CONVERTED TO 3 ADA PARKING SPACES WHICH ELIMINATED ACCESSIBLE AISLE. REMOVE MIDDLE SPACE AND STRIPE AS ACCESSIBLE AISLE.

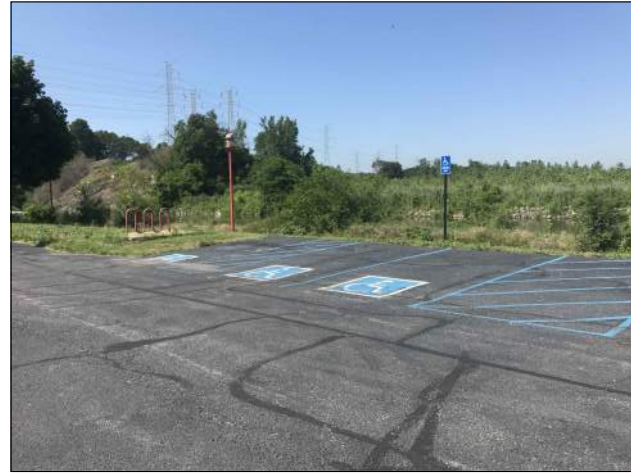
2. ADA PARKING SPACES AT FISHING PLATFORM - 3 SPACES, PARKING LOT SLOPE EXCEEDS MAXIMUM ALLOWABLE SLOPE FOR ADA SPACE AND ACCESSIBLE ROUTE (MUST BE LESS THAN 2% COMBINED IN ALL DIRECTIONS) RELOCATE SPACES TO LEVEL AREA.

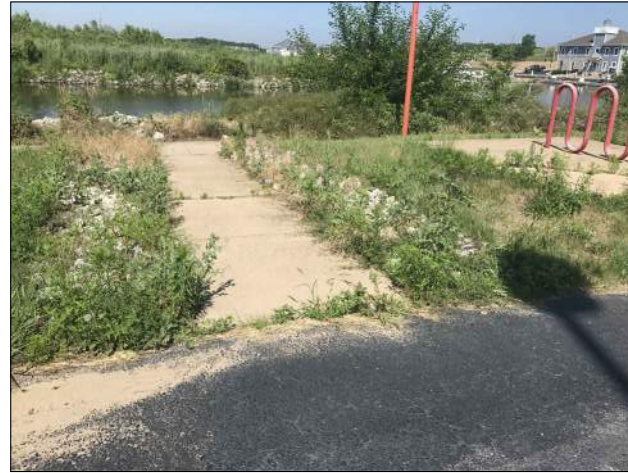
3. ACCESSIBLE ROUTE TO FISHING PIER IS OBSCURED BY OVER GROWTH AND LOCATION IS NOT READILY APPARENT. REMOVE OVERGROWTH MATERIAL AND SIGN LOCATION AS ACCESSIBLE ROUTE.
4. BIKE RACK IS LOCATED ON ELEVATED CONCRETE SLAB IN LAWN AREA. PROVIDE ACCESSIBLE ROUTE TO BIKE RACK OR RELOCATE BIKE RACK TO NEW AREA AND PROVIDE CONCRETE SLAB AT GRADE AND ACCESSIBLE ROUTE.

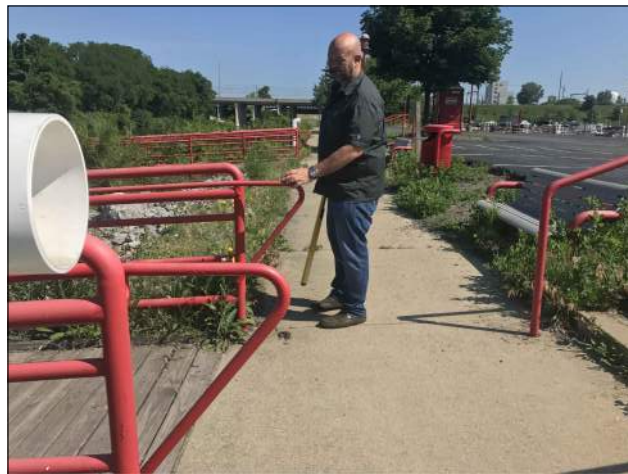
5. FISHING PLATFORM RAILINGS DO NOT MEET CURRENT ACCESSIBILITY REQUIREMENTS FOR PERCENTAGE OF ACCESSIBLE RAIL. RAILINGS FOR RAMP AND STAIRS PROTRUDE INTO THE ACCESSIBLE ROUTE. IF FUTURE IMPROVEMENTS ARE MADE TO THE PLATFORM RECOMMEND REPLACEMENT OF RAILINGS TO MEET CURRENT REQUIREMENTS. CONSIDER ALTERNATE ACCESSIBLE ROUTE TO ELIMINATE RAILING PROTRUSION.

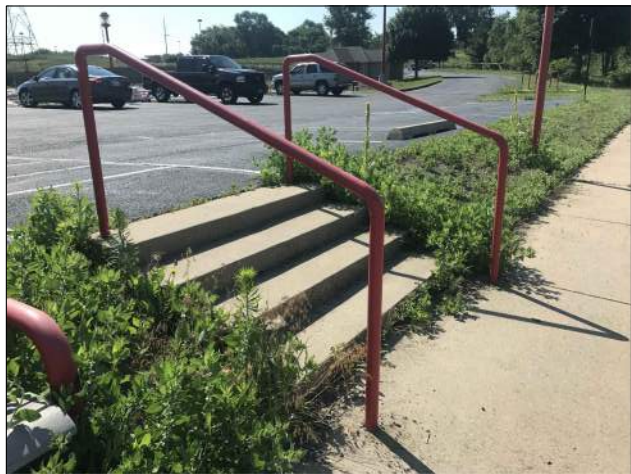
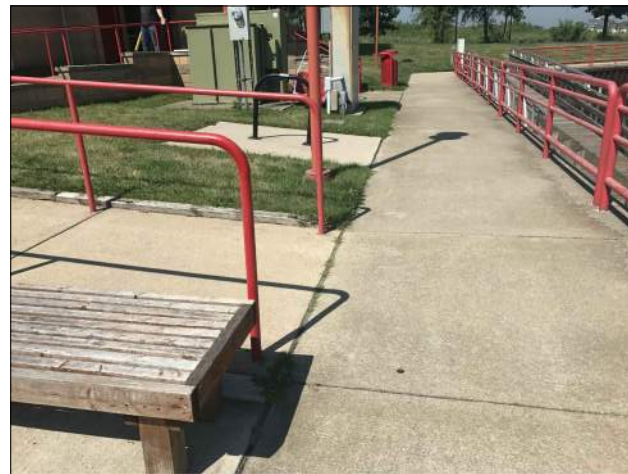
6. BOATER RESTROOM/SHOWER - RAILINGS FOR LOWER RAMP DO NOT MEET CURRENT STANDARDS - TO EXTEND 12" BEYOND LEVEL LANDING. RAILING ON RAMP PARALLEL TO FACE OF BUILDING NOT NEEDED AS SLOPE IS BELOW 5%. RAMP PERPENDICULAR TO MARINA IS AT 5.3% SLOPE REQUIRING A HANDRAIL. IF EXTENDED HANDRAILS WOULD PROTRUDE INTO MARINA WALKWAY AND LEVEL LANDING AT TOP OF RAMP. EXTENSION OF HANDRAIL WOULD CREATE A HAZARD DUE TO PLAN CONFIGURATION OF WALKWAYS..

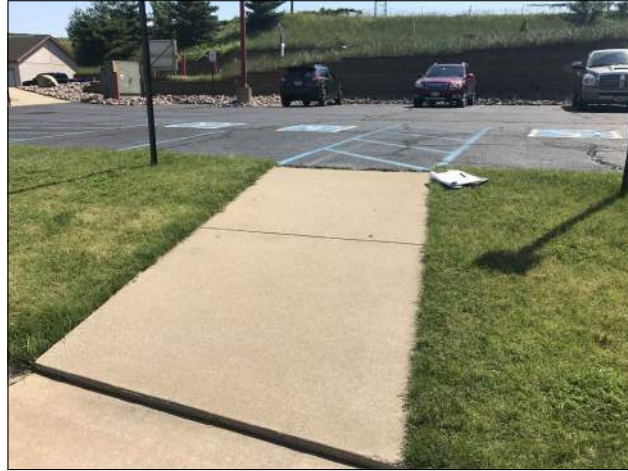
7. ADA PARKING SPACE SIDEWALK ADDED TO CONNECT TO MARINA WALKWAY IS SLOPING AT 7.5% AND IS HEAVED AT THE BASE CREATING A TRIP HAZARD. WALKWAYS SLOPING AT OVER 5% BECOME A RAMP REQUIRING HAND RAILINGS. WOULD RECOMMEND EITHER REDUCING SLOPE TO LESS THAN 5% WITH A WALK WITH SWITCH BACK OR IF POSSIBLE MAXIMIZING RAMP GRADE TO 8.33% AND ALLOWING 12" LEVEL AREA AT BASE OF WALK SO HANDRAIL DOES NOT PROTRUDE INTO MARINA WALKWAY AT LANDING.

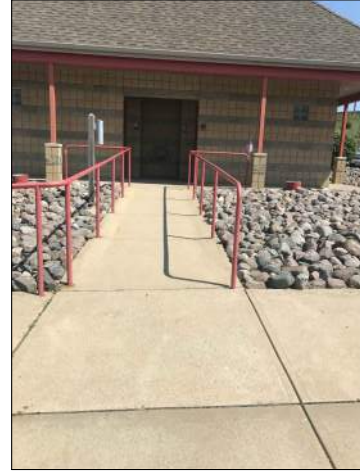
8. ADA RAMP AT EAST END OF BOATHOUSE DOES NOT HAVE A LEVEL LANDING - RECOMMEND WHEN MILL AND FILL OF ADJACENT ASPHALT PAVEMENT, RE-POUR LANDING TO HAVE LESS THAN 2% OF SLOPE IN ALL DIRECTIONS.

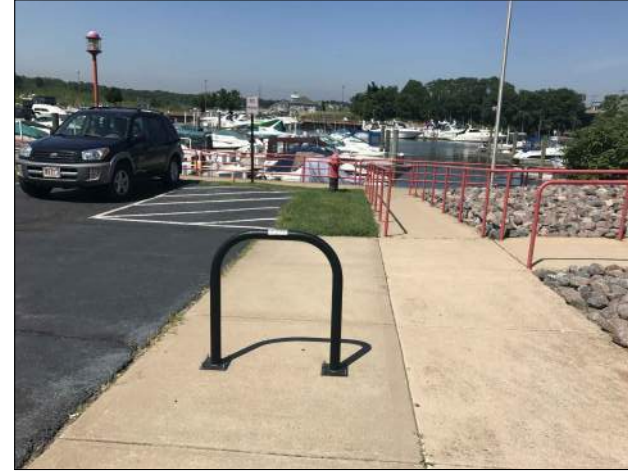
9. EXISTING BIKE RACK IS IN A LOCATION WHERE SECURED BIKE WOULD PROJECT INTO WALKWAY OR STICK OUT INTO ASPHALT PARKING AREA. RECOMMEND RELOCATING BIKE RACK TO LEVEL AREA WITH ADEQUATE SPACE TO ACCOMMODATE 2' WIDE X 6' LONG BIKE WITHOUT PROJECTING INTO CIRCULATION ROUTES.

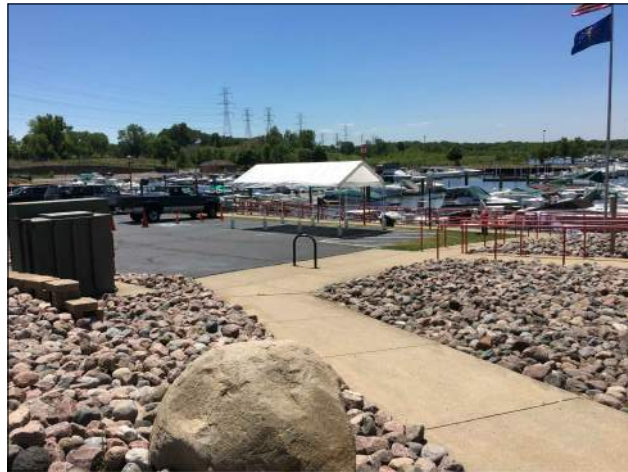
10. ANGLED SIDEWALK HAS A SEVERE CROSS SLOPE OF ALMOST 4%. CROSS SLOPES SHOULD BE 2% MAX. WOULD RECOMMEND REMOVAL OF WALK AND CONCRETE AREA ADJACENT TO PARKING LOT TO CREATE A LEVEL LANDING AND INSTALL WALKWAY TO MEET CURRENT STANDARDS.

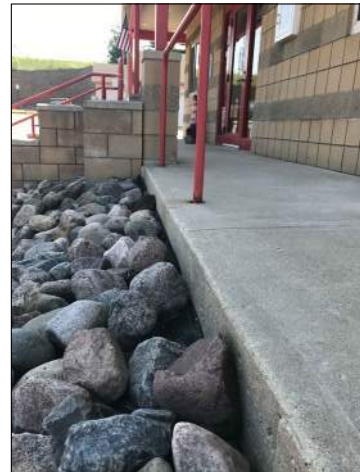
11. EDGE OF WALKWAY SHOULD HAVE A EDGE PROTECTION EITHER A CURB OR ADD STONE TO EXTEND ABOVE THE GRADE OF THE WALK TO CREATE A LIP.

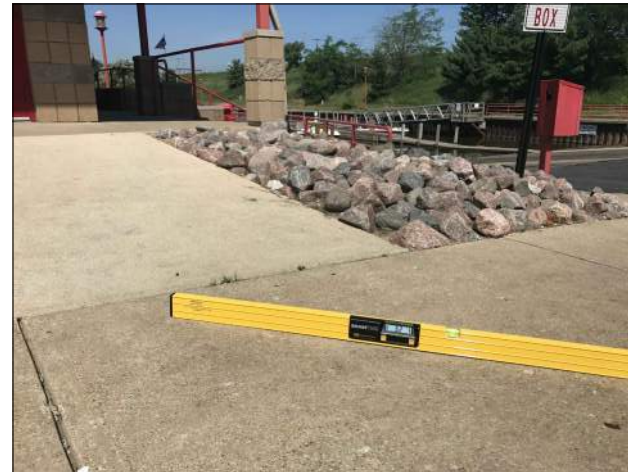
12. WALKWAY LEADING TO HARBOR MASTER AREA DOES NOT HAVE A LEVEL LANDING TO TRANSITION ONTO WALK. RECOMMEND EITHER CREATING LEVEL LANDING OR ADD SIGNAGE DIRECTING USER TO ACCESSIBLE RAMP TO SOUTH.

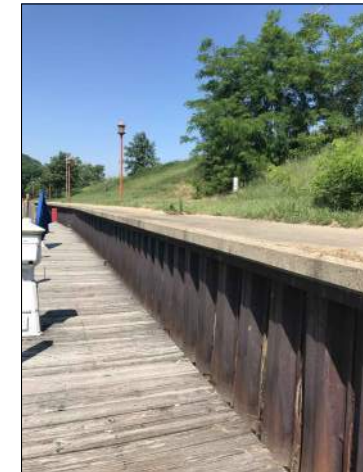
13. ELEVATED WALKWAY HAS APPROXIMATELY 3' DROP TO MARINA DECKING BELOW. SURFACES WITH 30 INCH OR GREATER DROP REQUIRE A GUARDRAILING.
